## To Evaluate Rangeland Riparian Health

**These steps provide a simple, semi-quantitative guide for evaluating riparian health.**

## The Montana Allotment: A Grazing Success Story

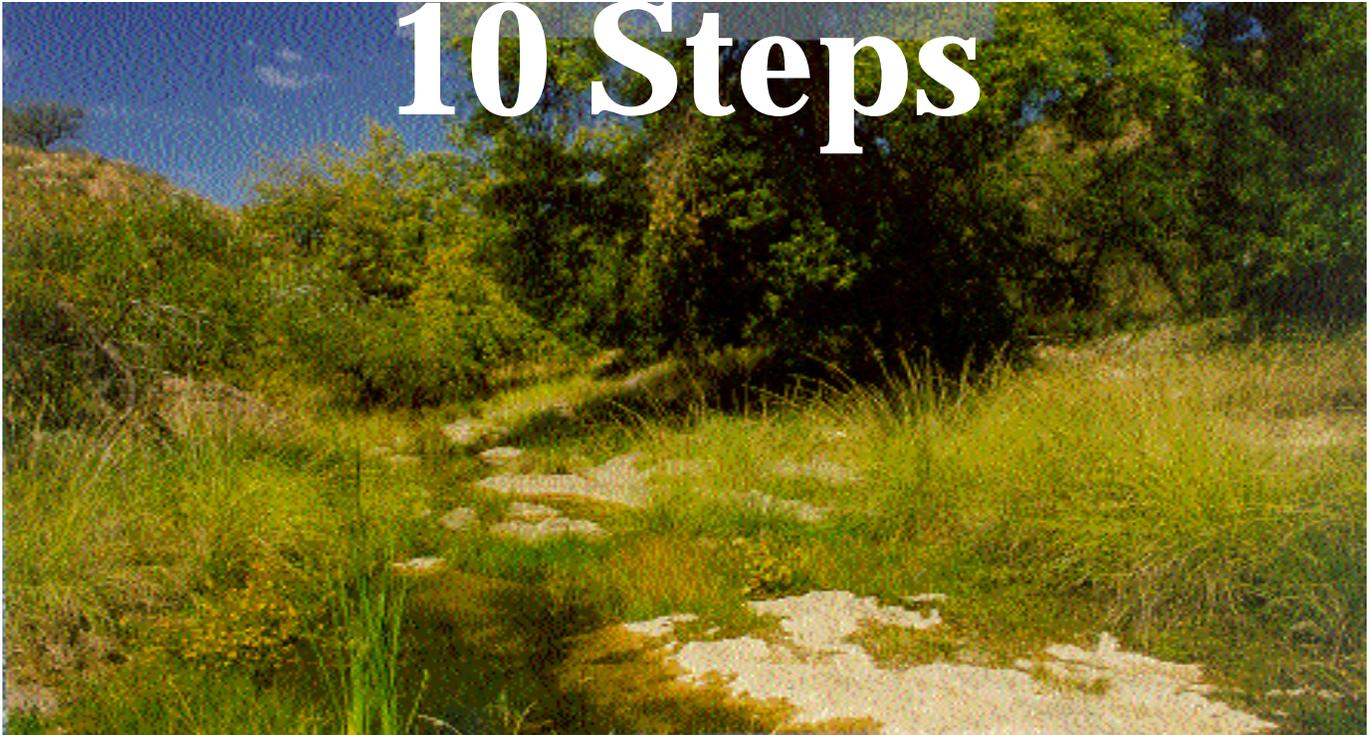
### Photo ID for page 22

*Riparian habitat in excellent condition in California Gulch on the Montana Allotment in September 2000. A combination of conservative utilization and rest rotation grazing has given high rate of increase of desirable riparian grasses and woody plants.*

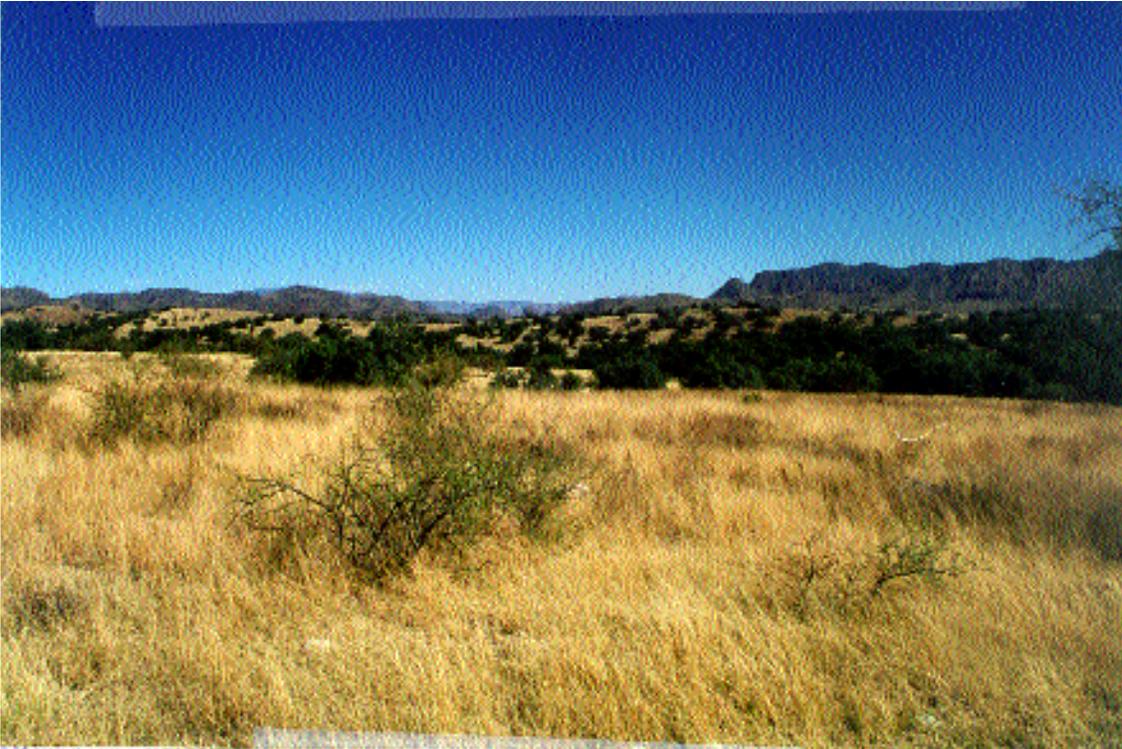
*Upland rangeland in excellent condition on the Montana Allotment in October 2000. In the period from 1984 to 2000 upland ecological condition has shown major improvement from a combination of conservative stocking, rest rotation grazing and improved live stock distribution.*
